CROOKED LAKE
WATERSHEDS OF THE CARPENTER AND PALFREYMAN DITCHES
FEASIBILITY STUDY

T BY 2000
LAKE ENHANCEMENT PROGRAM

William W. Hill & Associates

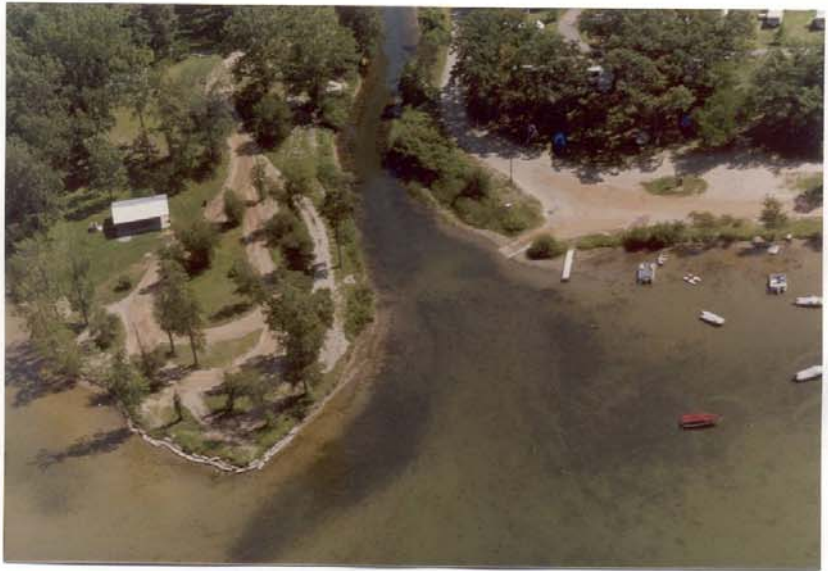
Figure II. Palfreyman Ditch entering Crooked Lake;
Normal Conditions.

and measurements have indicated severe nutrient and sediment loads in the entering streams to the lake. Figures II through VIII, taken in June 1988, clearly indicate the severity of the sediment problem at the mouth of both drains. The two streams enter the lake less than one-half mile apart, on either side of the county park and campground.

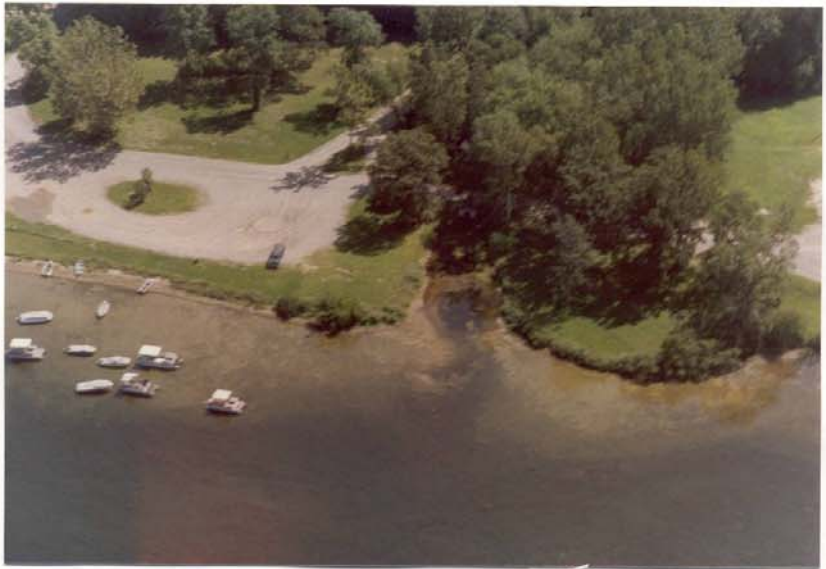
Figure III. Carpenter Ditch entering Crooked Lake;
Normal Conditions.

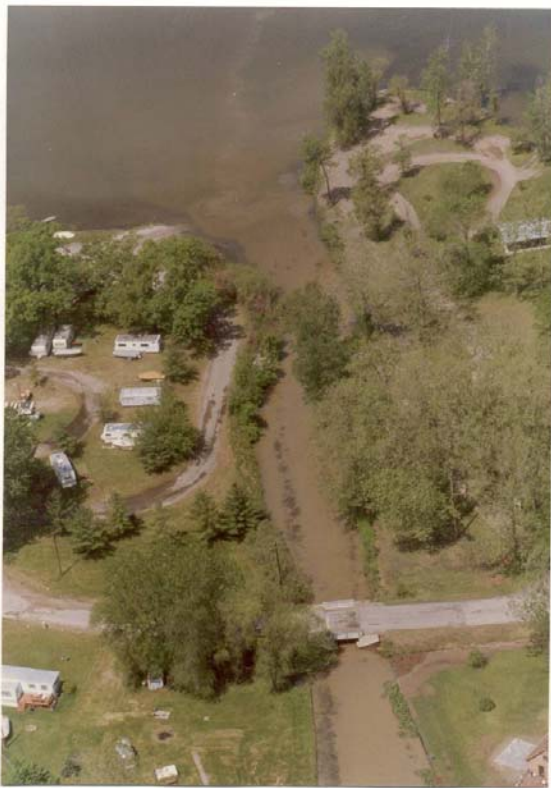
Figure IV. Palfreyman Ditch entering Crooked Lake; Storm Conditions.

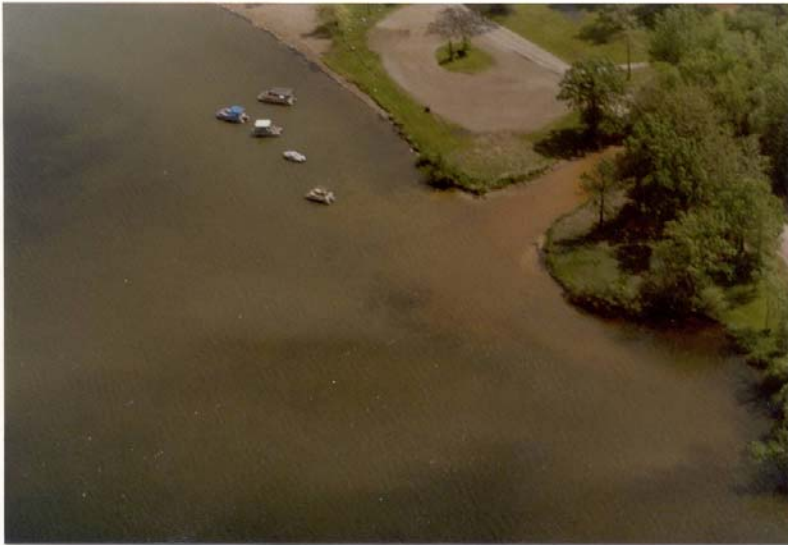
Figure V. Carpenter Ditch entering Crooked Lake; Storm Conditions.

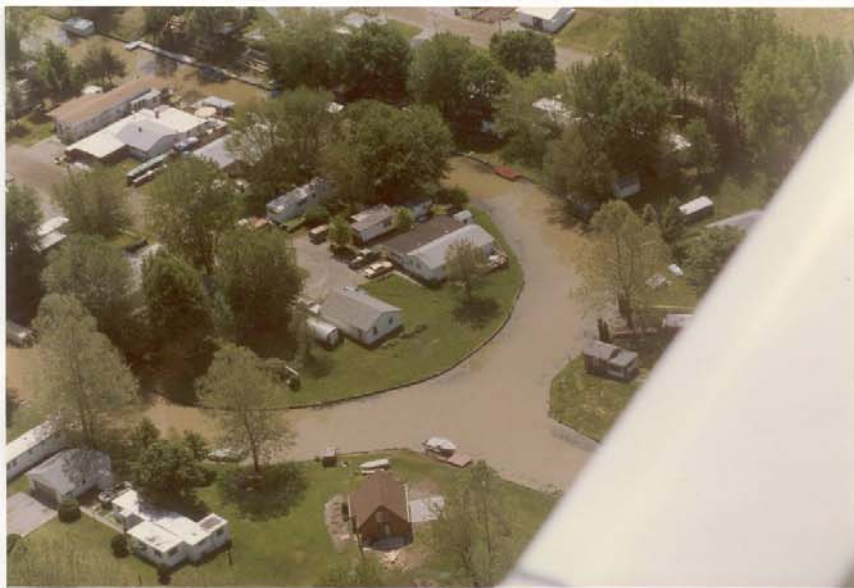
Figure VI. Channels upstream of the mouth of Palfreyman ditch; Storm Conditions.

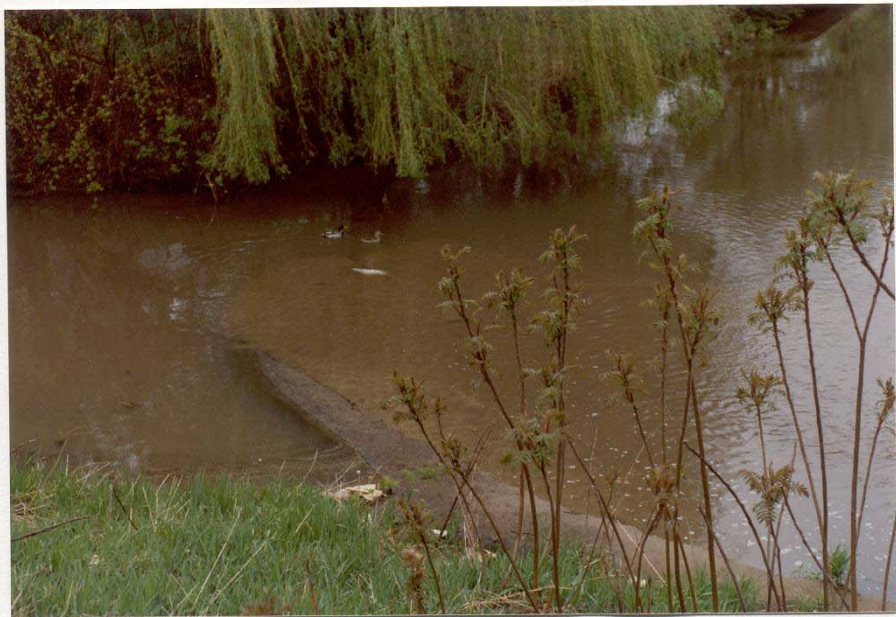
Figure VIII. Typical bar formation at exit of Palfreyman culvert.

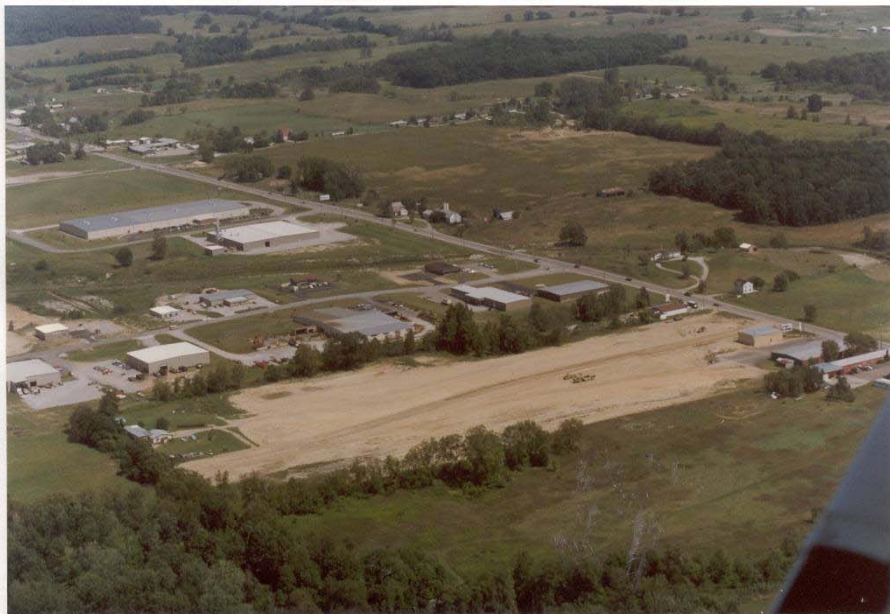
Figure IX. Site preparation near Palfreyman Ditch; Erosion control ordinances needed.

The nutrient levels are the result of several land uses while the sediment problems are largely the result of improper management of the topsoil and control of flow rates. Figure IX depicts a typical lack of erosion control during construction at a site along the Palfreyman Ditch.
